Durability of Posttensioned Concrete After 33 Years of Marine Exposure

Technical Report SL-97-9
September 1997

by Morris Schupack

- 1.1** The purpose of this report is to provide the history and results of the exposure tests of twenty post-tensioned beams installed in 1961 at the Corps of Engineers Severe Weather Exposure Station at Treat Island, Maine¹. The report assembles the data and evaluates the findings. From this overall study, the important durability issues are reported, the decision on which additional beams to be autopsied are recommended and the best long term behavior features are identified. Details and materials which provide long term durability for similar construction are recommended.

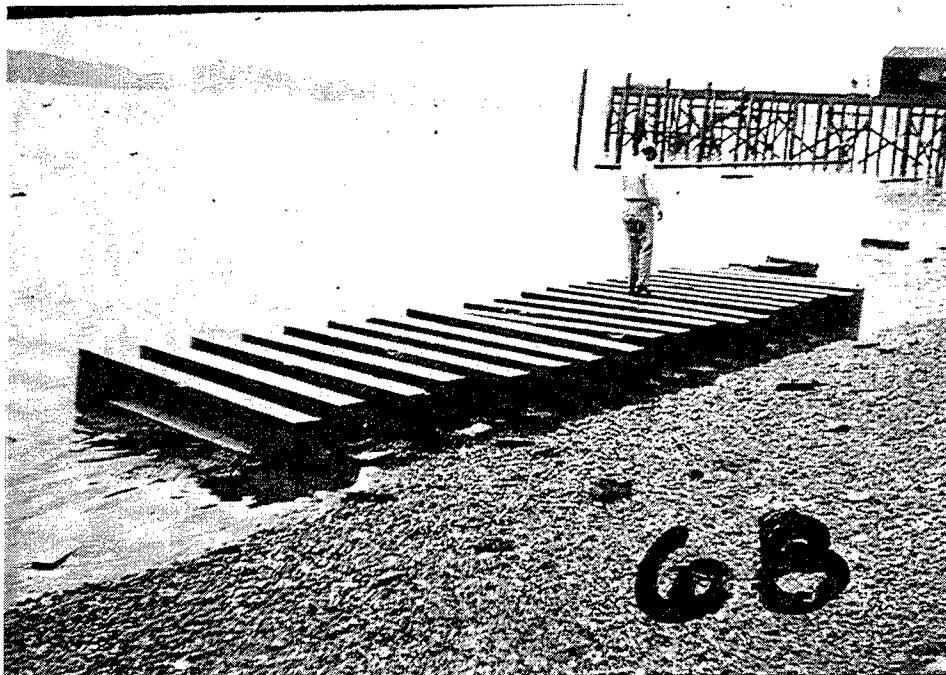
Fig. 1A

1968 - Twenty post tensioned beams partially submerged.

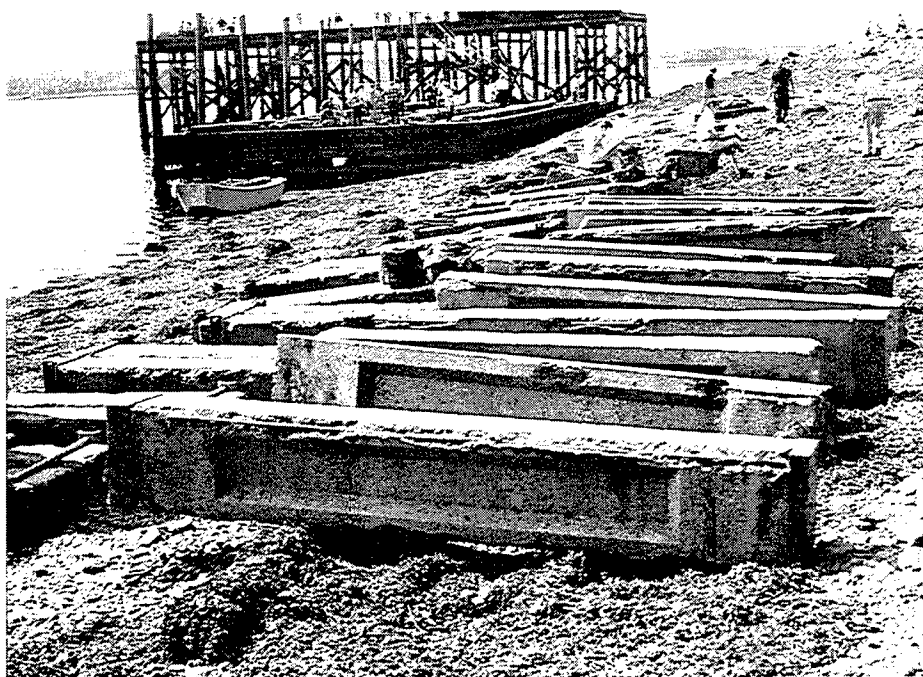
Fig 1B

1986 - Nine remaining post-tensioned beams in foreground.

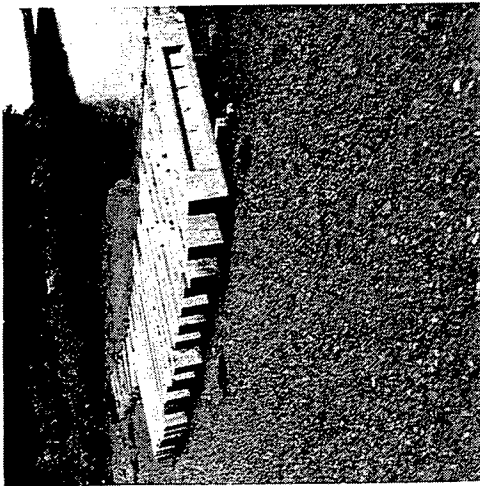
Fig. 2A

1962 - 20 Beams placed in 1961

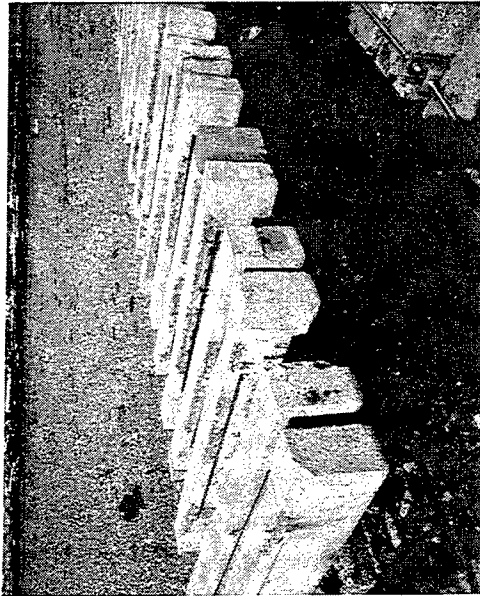
Fig. 2B

1972 - 20 beams

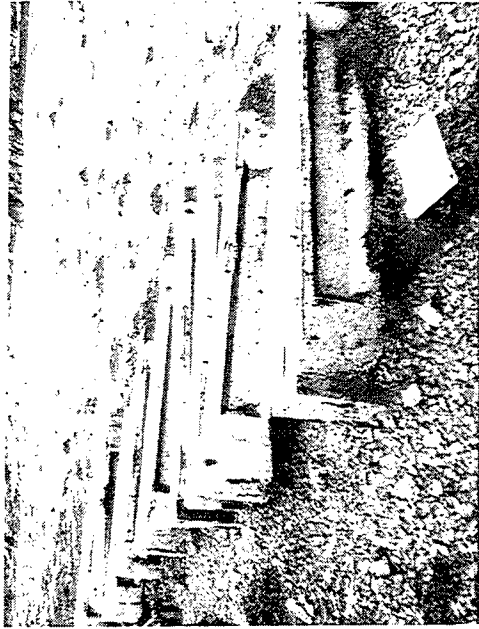
Fig. 2C

1982 - 12 beams remaining - 8 removed
for autopsy at WES in 1973 and 1974

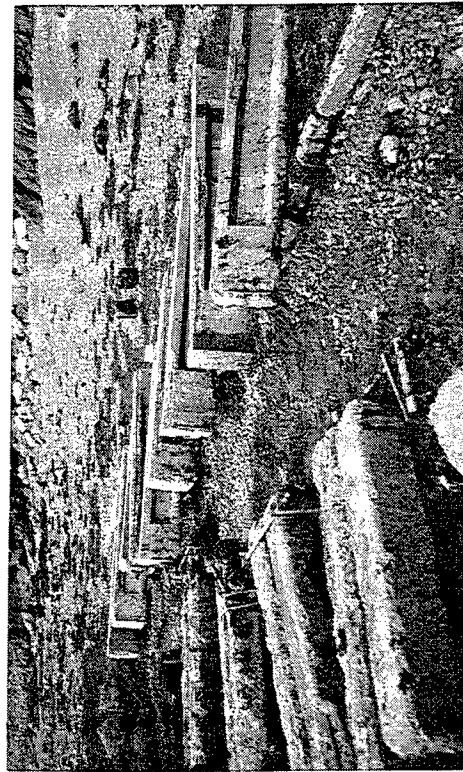
Fig. 2D

1990 - 9 beams remaining - 3 removed for autopsy at WES in 1984

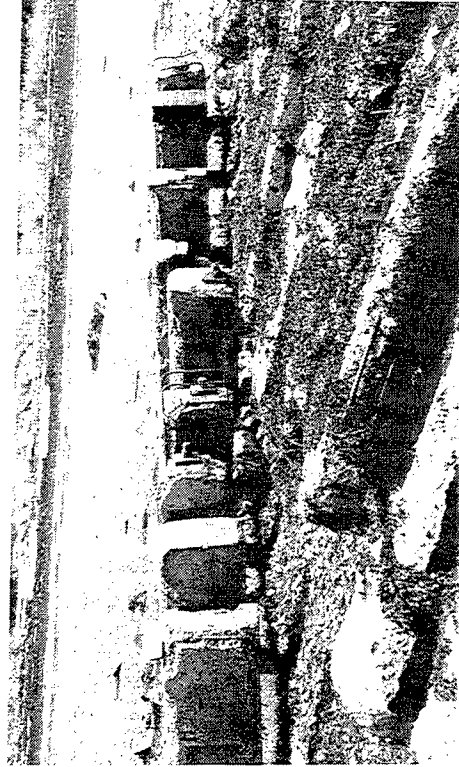
Fig. 2E

1994 - 9 post-tensioned beams at Treat Island

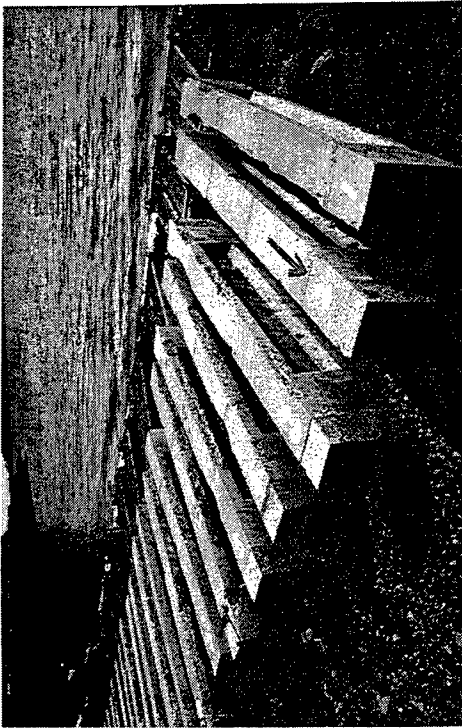
Fig. 5-1A

Beam 2 - Looking seaward - 1972

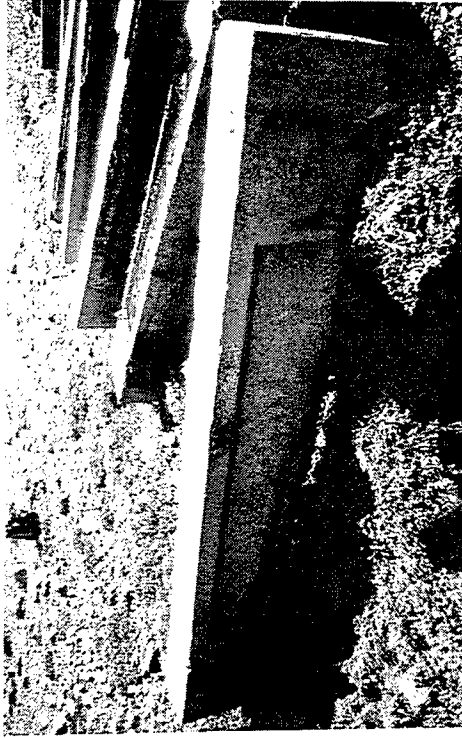
Fig. 5-1B

Beam 2 - 1978

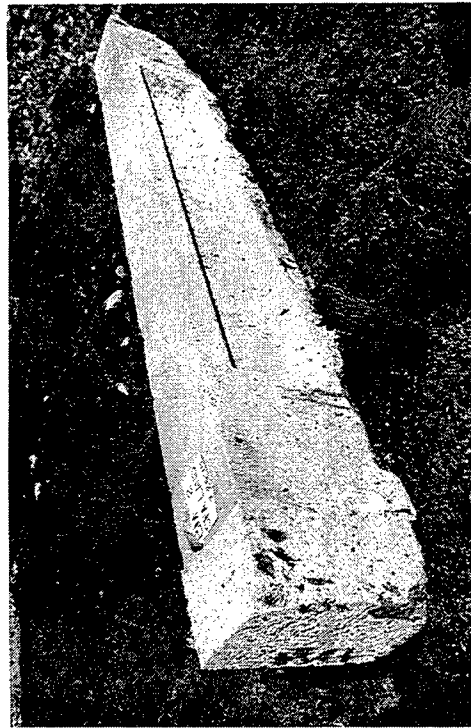
Fig. 5-1C

Beam 2 - 1978

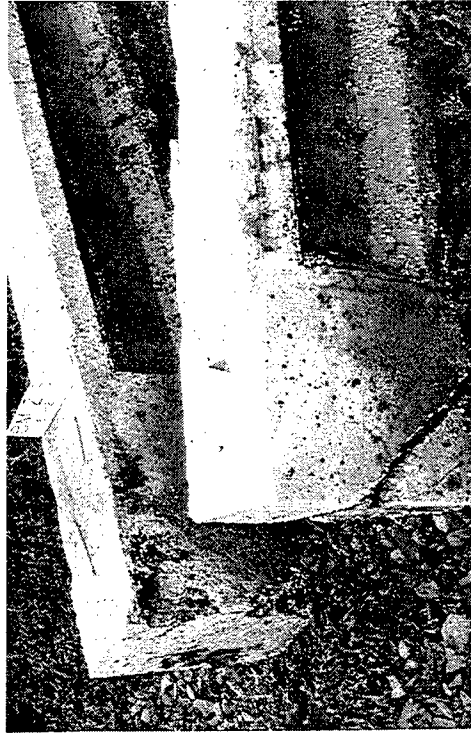
Fig. 5-1D

Beam 2 - Landward end - 1982

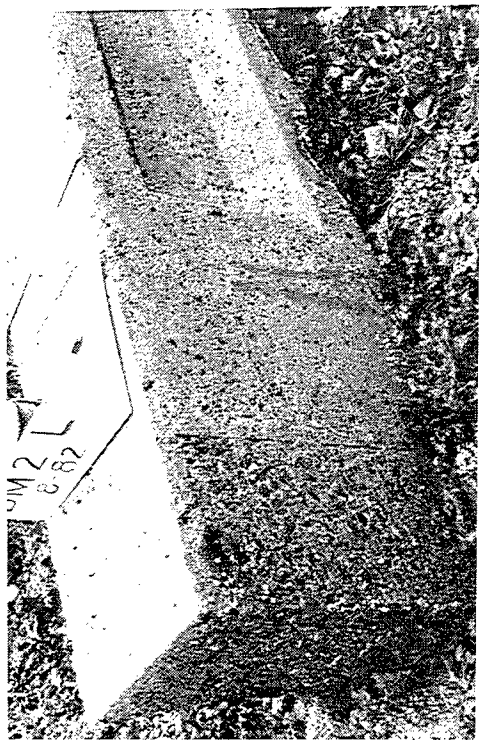
Fig. 5-2E

Beam 2 - Landward end - 1982

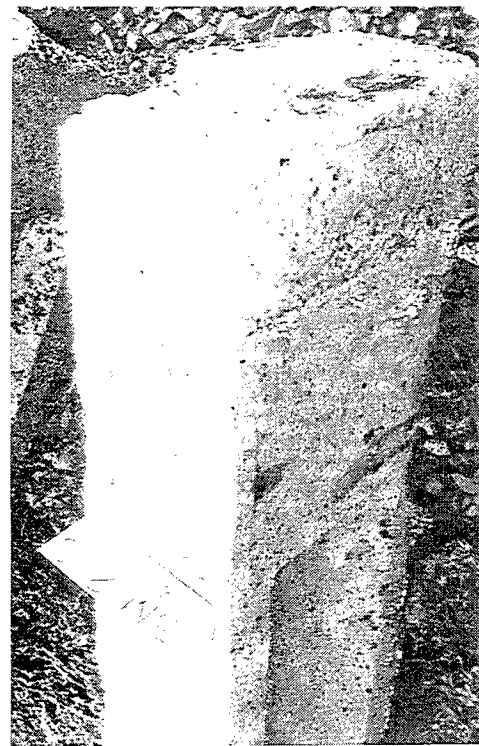
Fig. 5-2F

Beam 2 - Seaward end - 1982

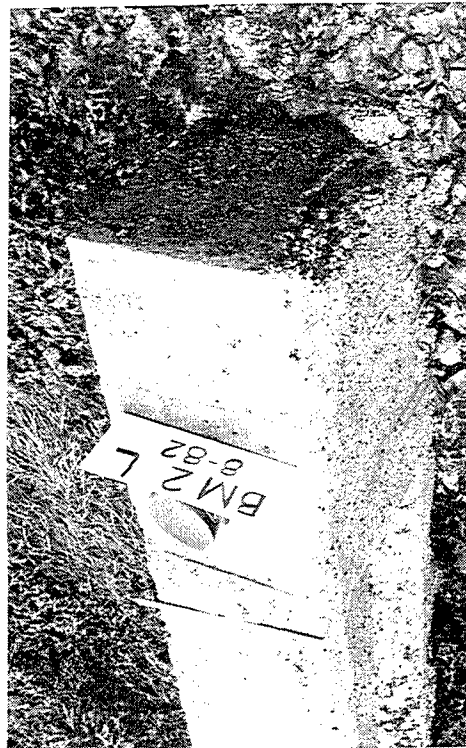
Fig. 5-2G

Beam 2 - Landward end - 1982

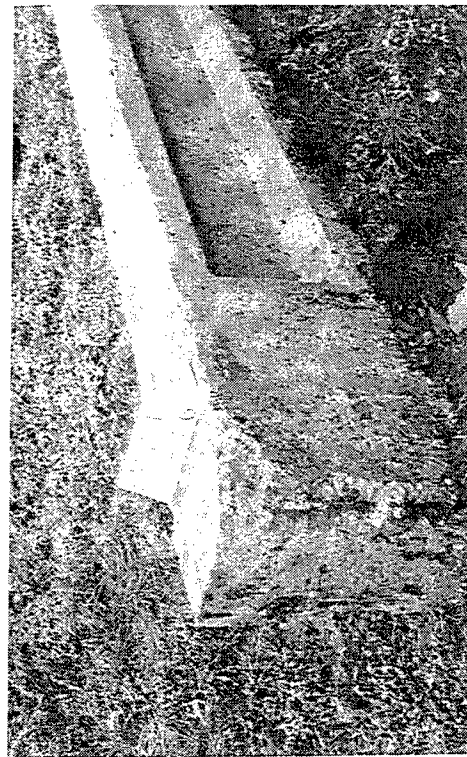
Fig. 5-2H

Beam 2 - Landward end - 1986

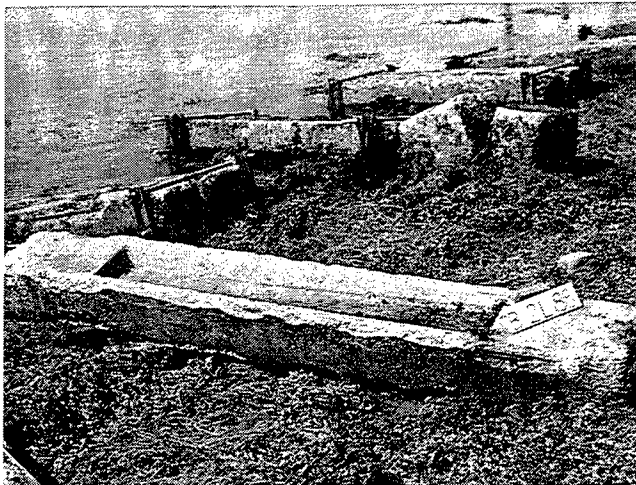
Fig. 5-3I

Beam 2 - 1988

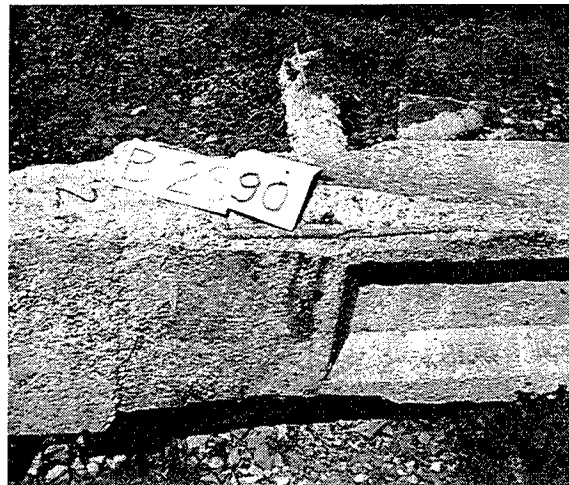
Fig. 5-3J

Beam 2 - Seaward end - 1990

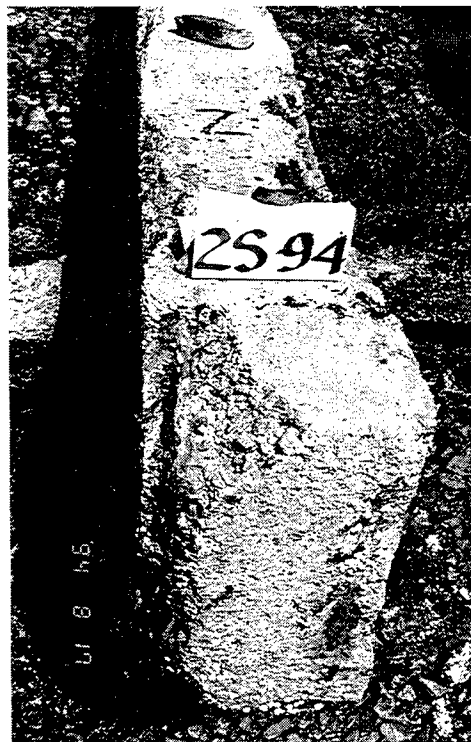
Fig. 5-3L

Beam 2 - Seaward end - 1994

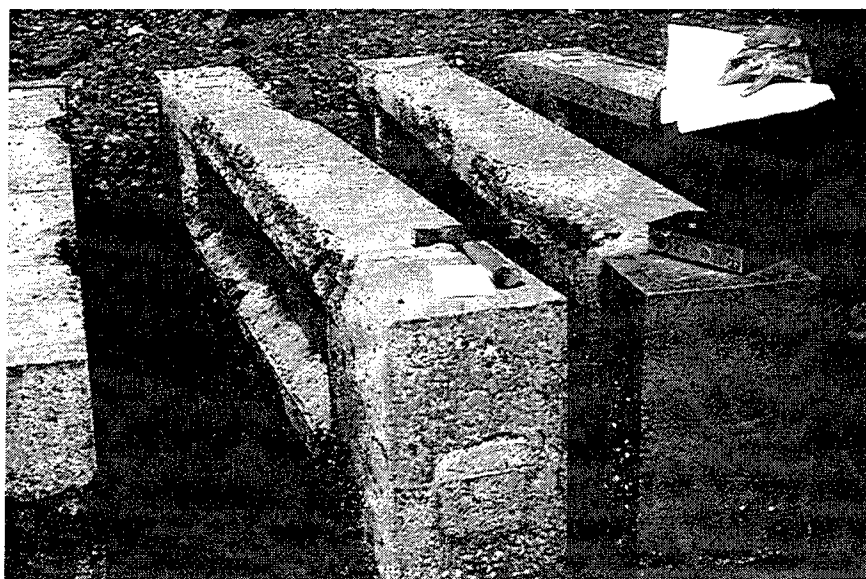
Fig. 6A

Beam 5 - Seaward end - 1972

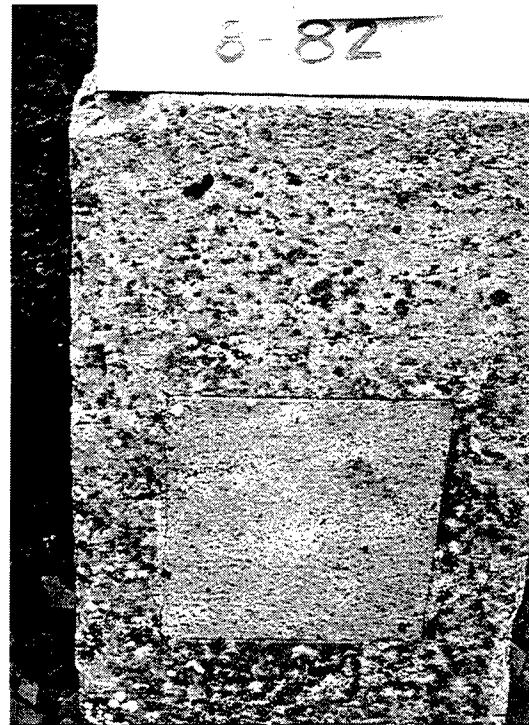
Fig. 7-1B

Beam 12 - Seaward end - 1982

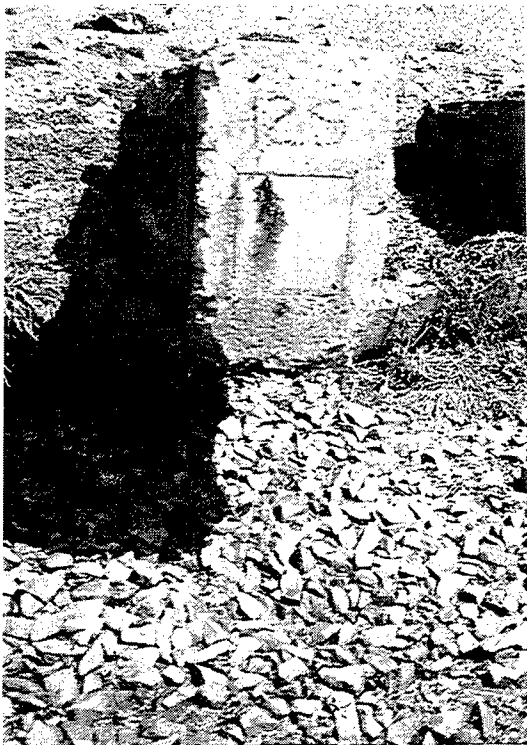
Fig. 7-1C

Beam 12 - Seaward end - 1990

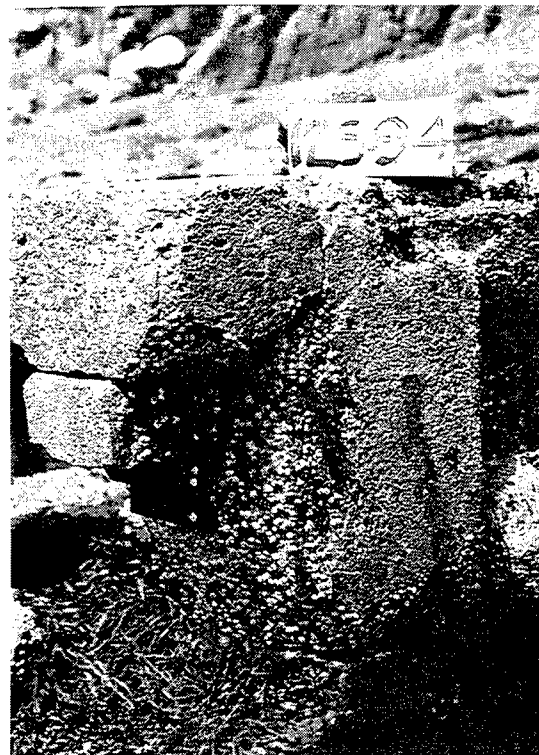
Fig. 7-1D

Beam 12 - Seaward end - 1994

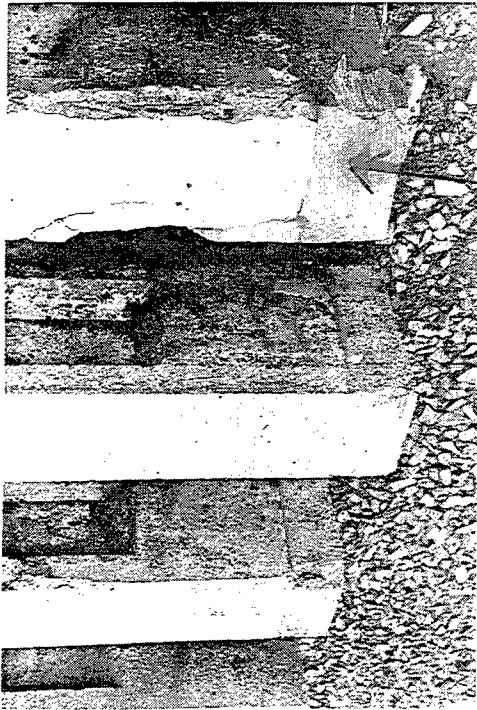
Fig. 7-2E

Beam 12 - Landward end - 1968

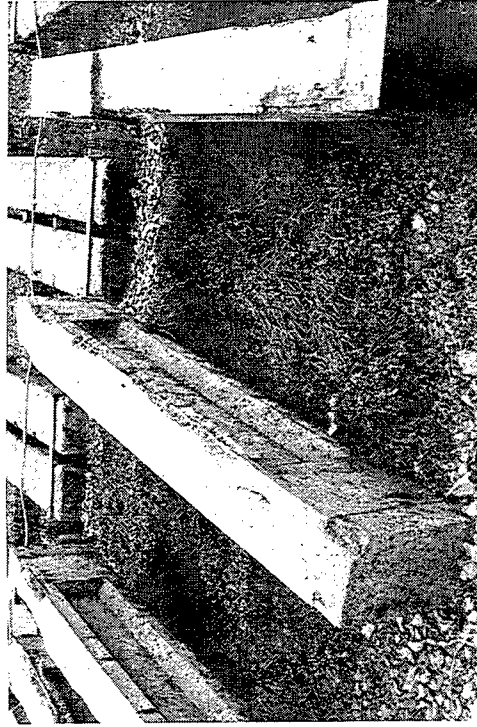
Fig. 7-2F

Beam 12 - Landward end - 1976

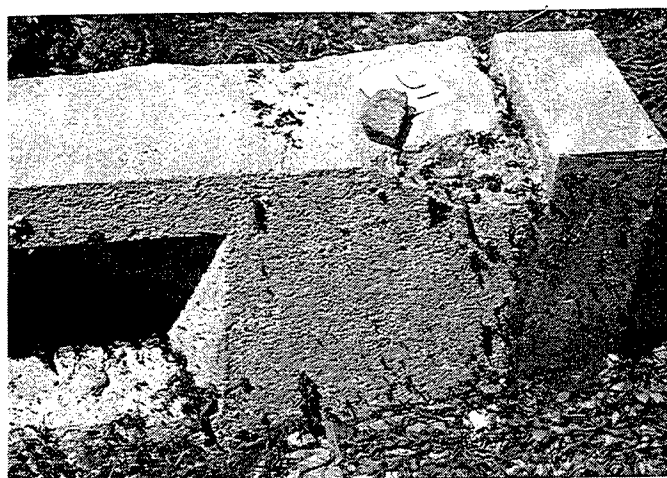
Fig. 8-2F

Although the epoxy-resin itself behaved very well for 33 years, the interaction between the epoxy-resin and the concrete manifested deterioration of the concrete interface and corrosion of the reinforcing steel that extended from the portland-cement concrete into the epoxy-resin concrete (Fig. 8-1, 8-2, and 8-3I). The concrete deterioration first appeared in 1972 in beam ends 16L and 20S. (Table 2-3). Prior to 1972 it appeared that the epoxy-resin concrete was a superior detail. The concrete deterioration was probably affected by the following conditions:

Beam 16 - Landward end - 1988

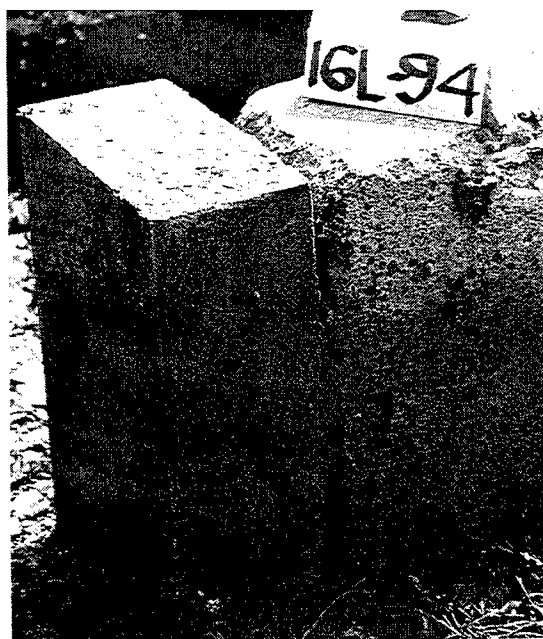
Fig. 8-2H

Beam 16 - Landward end - 1994

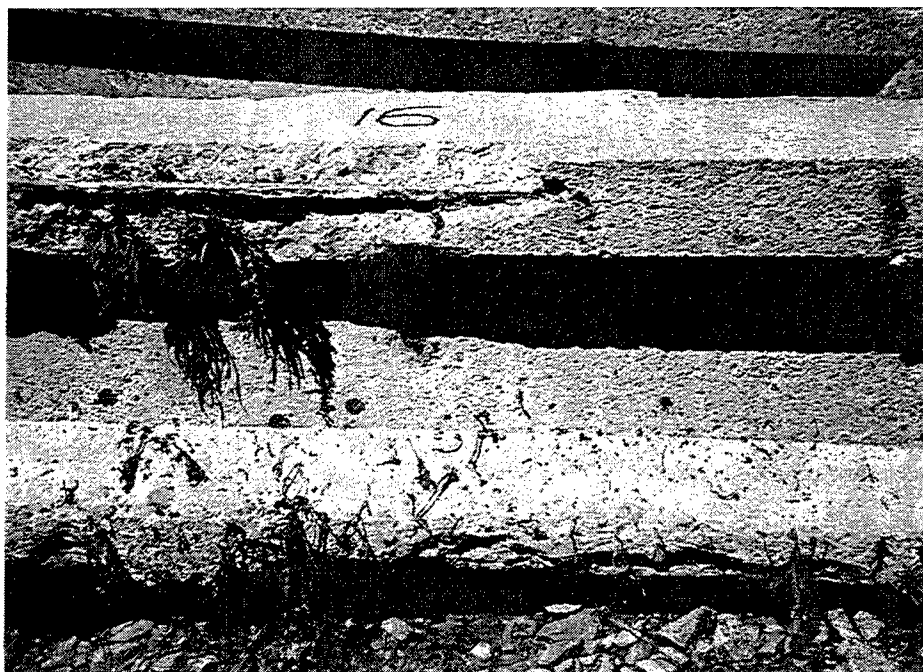
Beam 16 - 1990
Stirrup corrosion
Fig. 8-3K

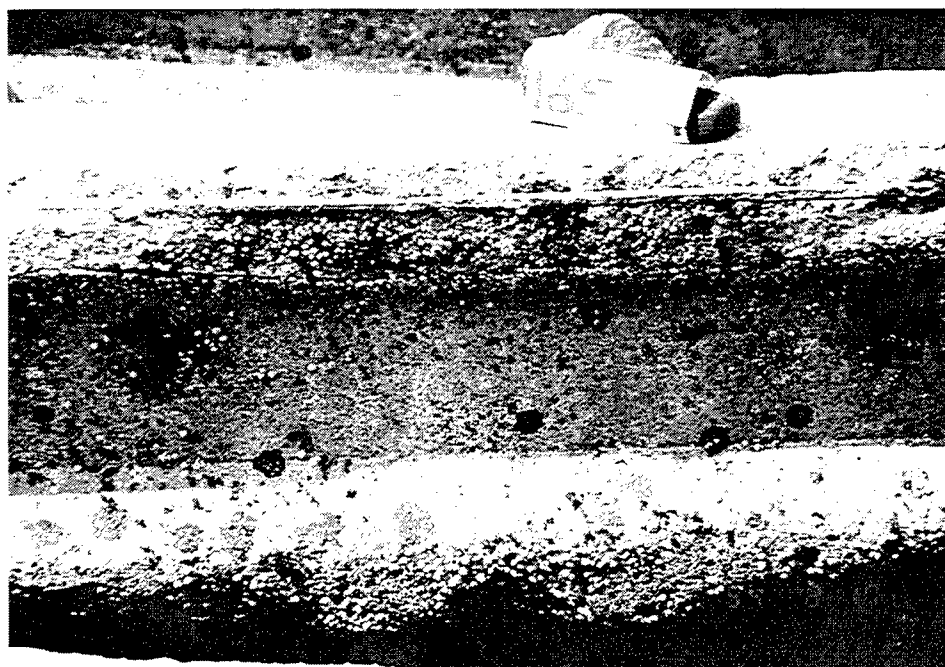
Fig 8-4N

Beam 16 - 1994

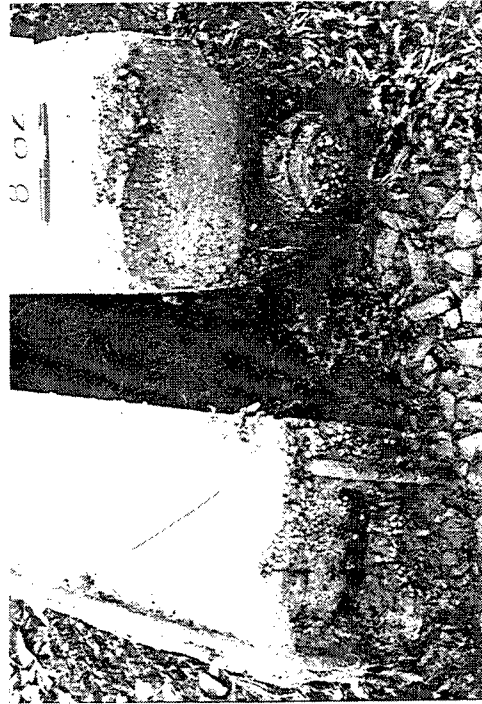
Beam 17 - Landward end - 1982
Before 1984 autopsy
Fig. 9-1D

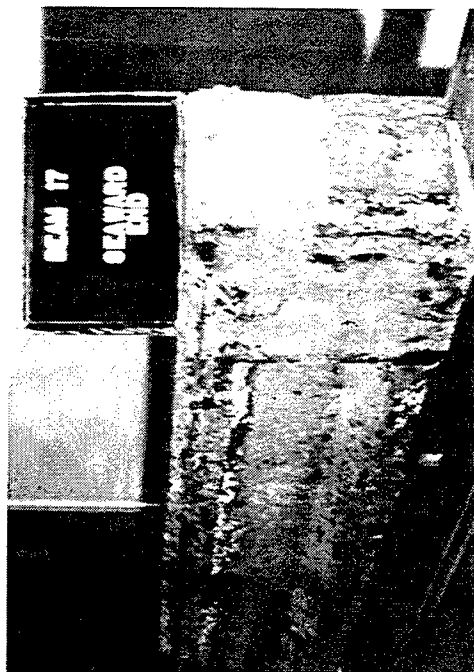
Beam 17 - Landward end - 1984
Prior to autopsy
Fig. 9-2F

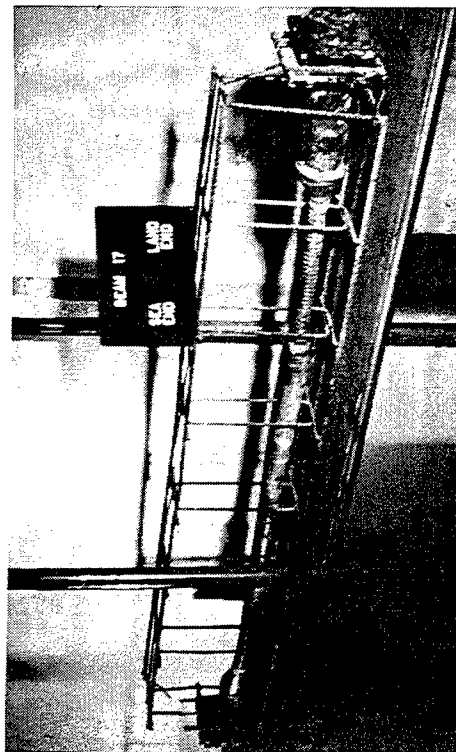
Fig. 9-2G

All beams contained normal reinforcing steel which was provided with a nominal 3/4-in. (19-mm) concrete cover. The details of reinforcement are shown in Fig. 3 and Table 4 of Appendix A. Figure 9-2G shows a typical reinforcing cage removed from an autopsied beam.

Beam 17 - Reinforcement cage - 1984

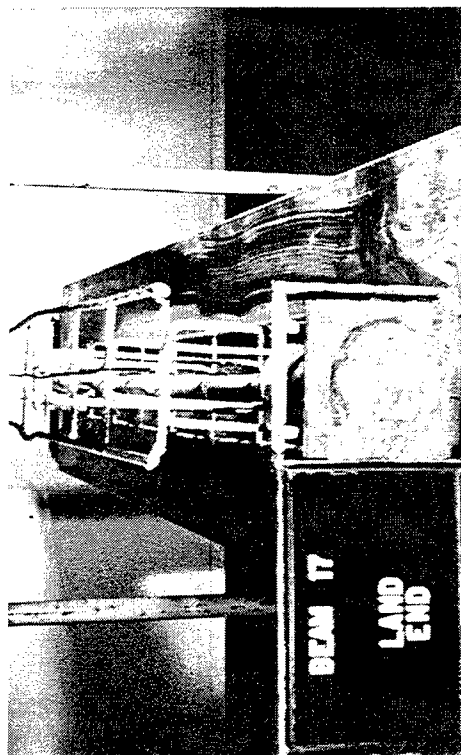
Fig. 9-2H

Beam 17 - Landward end reinforcement, anchorage - 1984

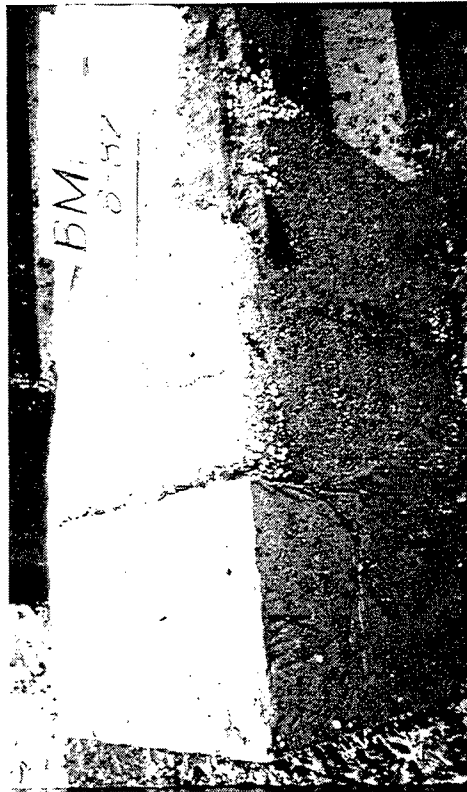
Beam 4 - Landward end - 1982
Epoxy external end protection
Fig. 10-1C

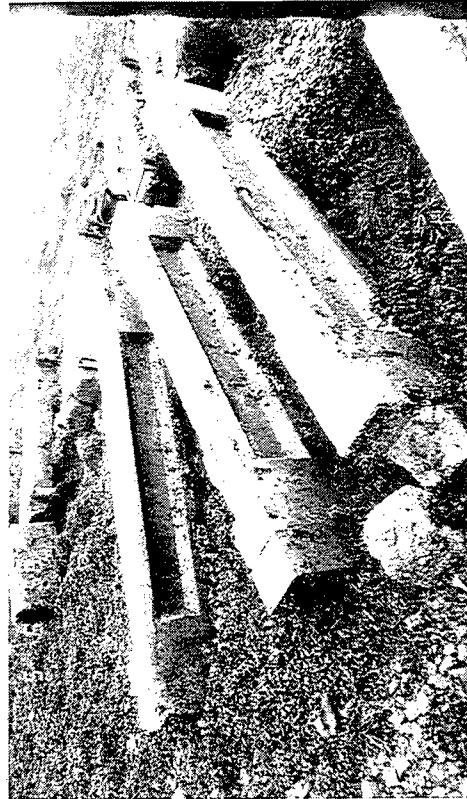
Fig. 10-1D

Beam 4 - Landward end - 1982

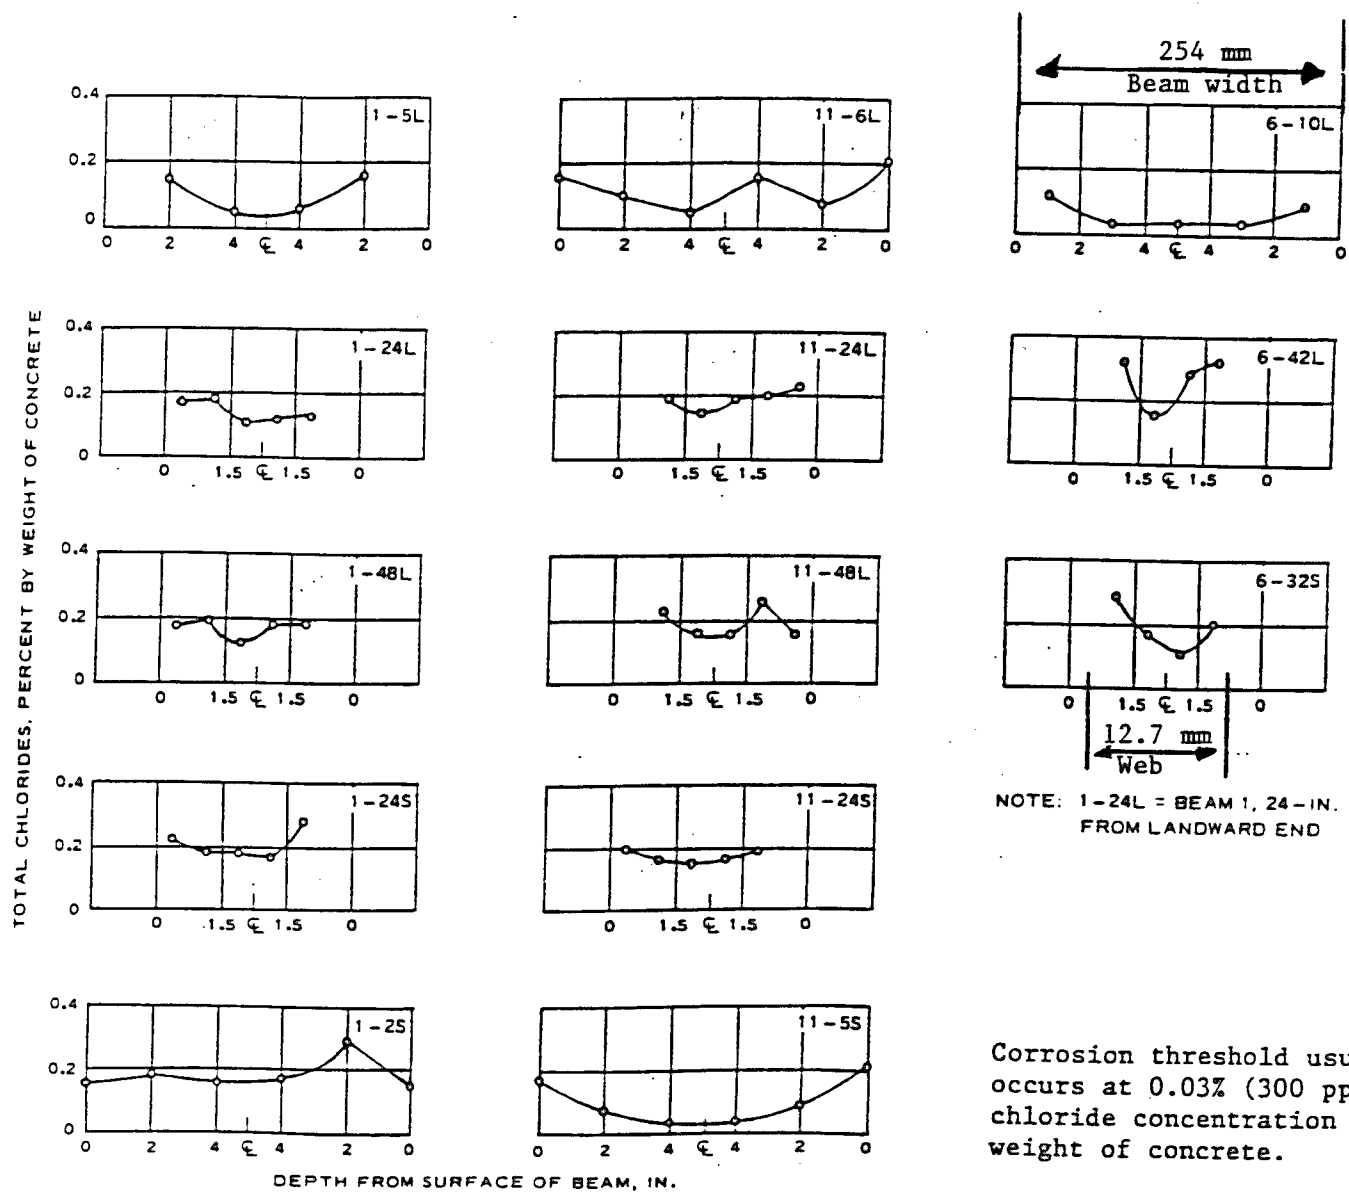
Fig. 11 - Total Chloride Content vs Depth from Vertical Beam Surface

In the 1973-74 autopsies as reported in the WES Report², the chloride gradient through the webs indicated sufficient chlorides to expect that all reinforcement would have been seriously corroded. Figure 11, was extracted from the WES Report and modified to show the chloride threshold at which there is a 90% chance that corrosion will occur. It is surprising that with this amount of chloride contamination found after twelve years, that the remaining nine 33 year old beams show very limited evidence of web stirrup corrosion.

Considering the high chloride content of the webs (Fig. 11), it would have been expected that corrosion of the sheath and eventually the enclosed prestressed steel would have been advanced. If additional beams are autopsied and it is found that the corrosion process has not progressed, then it can be speculated that the corrosion present on the prestressing steel wires may have occurred during the early stages of fabrication of the tendons and the beams. It appears at this time, that the portland-cement grout protecting the prestressing steel has afforded excellent protection.

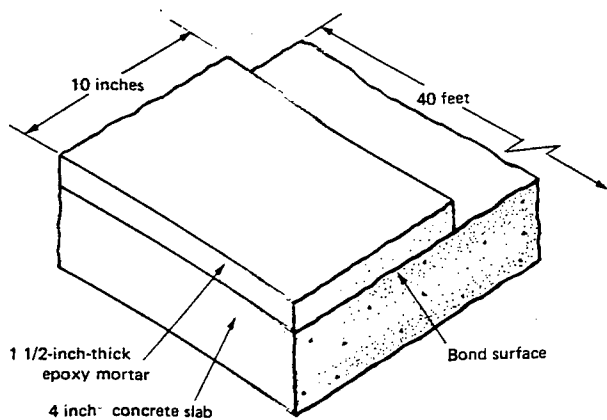
An epoxy mortar strip bonded to a concrete slab, as constructed.
